Daishowa Reduces Pump Maintenance by Installing Fluid Rotating Vanes

Installation diminishes noise and vibration caused by severe pump cavitation and eliminates need to rebuild pump every six months

By DARRELL A. DANIELSON

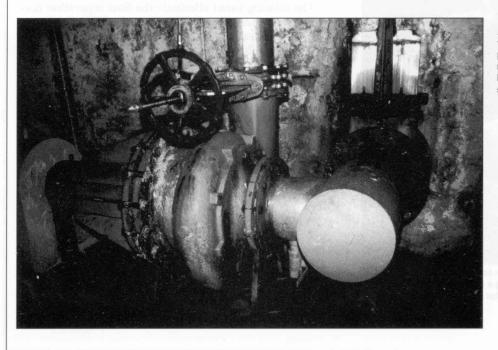
Unfortunately, this did not solve the inherent problem of unequal pressures and high localized velocities created when a flow changes direction by 90°. The characteristics of flow through an elbow are still maintained, causing cavitation and resulting in high maintenance costs, including a pump rebuild every six months. During these rebuilds, the impeller had to be replaced because of the extensive damage the cavitation had caused, even to the relatively hard surface of 316 stainless steel.

A whitewater pump installation at the mill was such that there was no possible way to obtain the necessary 5- to 10- pipe dia between an elbow and the pump suction.

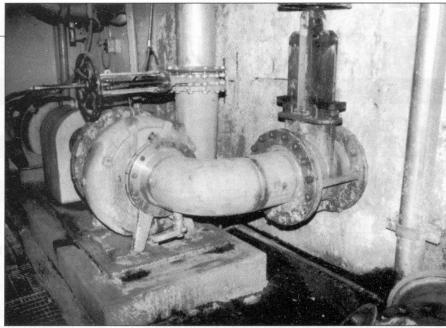
With the installation of the Cheng Rotating Vanes (CRV), even though the elbow is discharging directly into the pump intake, the flow into the pump is smooth and symmetrical, eliminating cavitation.

PROBLEM SOLVED. In February 1992, Daishowa replaced the stub tee with a standard 12-in. short radius elbow and a set of Cheng Rotating Vanes (CRV) (manufactured by Cheng Fluid Systems of Sunnyvale, Calif.) between the elbow and the knife gate. The CRV, a set of stationary foils, induce a rotation of the fluid prior to entry into the elbow, such that all the stream lines are of equal length through the elbow. The result is an even velocity/pressure distribution at the elbow discharge. Even though the elbow is discharging directly into the
