Curing cavitation saves money; cuts vibration, erosion damage

Vane straightener lowers pump maintenance and improves performance

Kenneth J. Clarke, Div. Engineer, DuPont Chemicals
With CP Staff

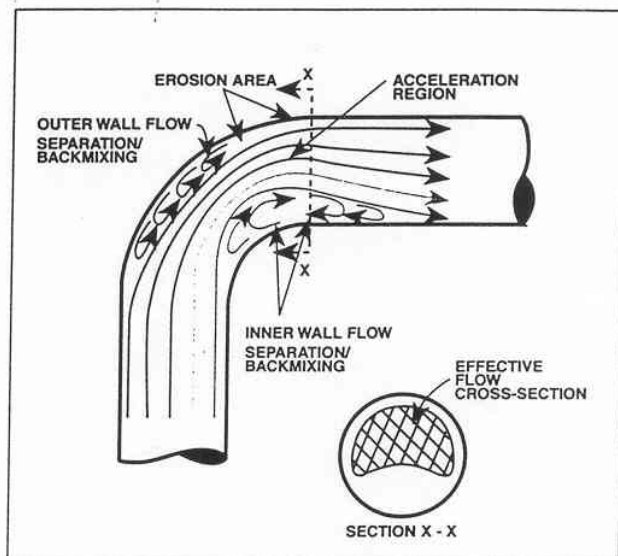
When fluid passes through an elbow, two flow regions occur (Fig. 1). Because of the separation, the fluid is forced through a reduced cross-sectional area and local velocity increases. Backmixing, separation and low pressure may even cause the liquid to vaporize if conditions are right. Such a disturbance can carry as far as 20 pipe diameters downstream. Unsuccessful attempts to correct the problem included a special suction elbow and a suction diffuser installed just upstream of the pump.

Above: Fig. 1. Without flow straightener, uncontrolled flow through an elbow separates fluid into two stream regions creating local high velocities and turbulence.

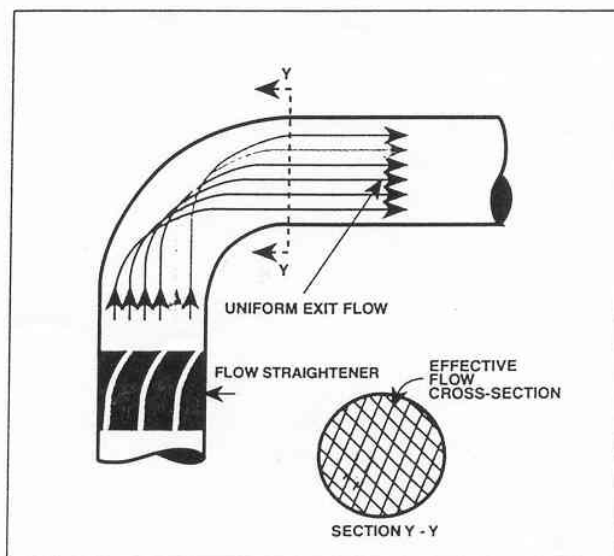
A patented flow conditioner consisting of a set of stationary vanes introduces a rotational effect into the fluid as it passes through the elbow. When installed upstream of an elbow, the straightener enables the fluid to negotiate the turn with all stream elements traveling the same distance from the entrance to the exit (Fig. 2).

Below: Fig. 2. Vane flow straightener imparts rotation to the fluid, allowing it to make the elbow turn with all stream elements traveling the same distance.
